Service Repair Documentation

Level 2.5 light - S65, SP65

1 S65, SP65 board layout

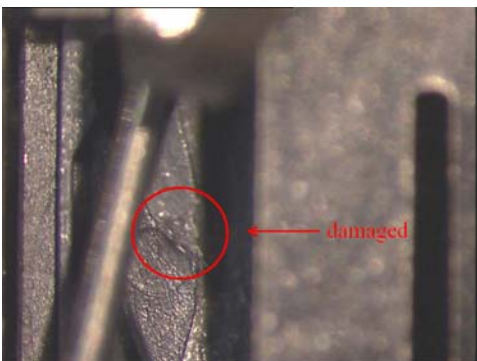
Lock mechanism damaged

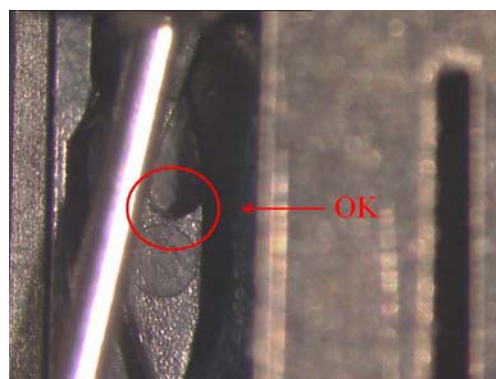
Lock mechanism OK

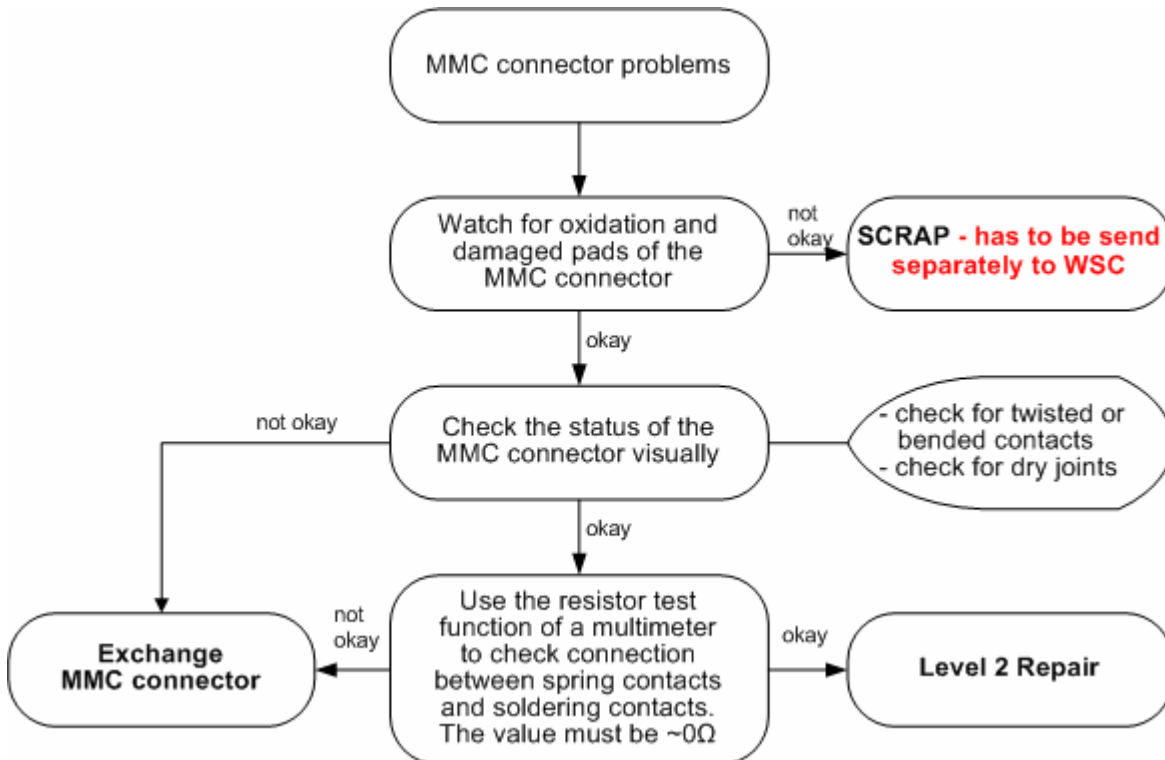
Connector MMC

Fault Symptoms	
Customer: MMC malfunction	GRT: Tbd.

Use soldering iron to remove defective component. Avoid excessive heat! Watch surrounding components!
 Resolder new component afterwards.

E-commerce order number: L36334-Z97-C342
 Soldering temperature: 240 - 255°C
 IRIS Diagnose Code: B1120 Accessories / Memory / MMC / Defect

Attention: Avoid excessive heat in order not to damage the plastic material of the connector (see problem SLIM-Lumberg connector)

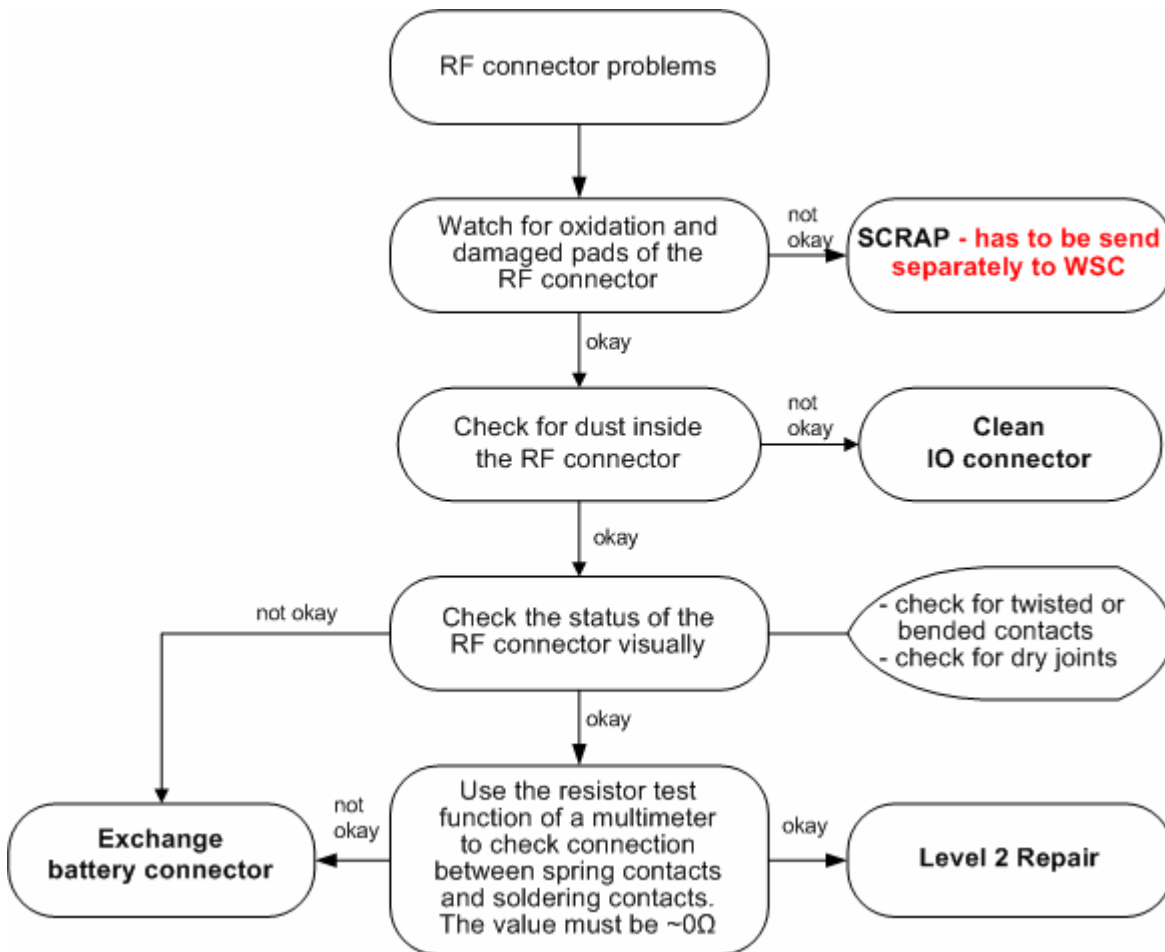
Connector RF

Fault Symptoms	
Customer: Network search No location update possible	GRT: Failure by TX/RX measurements No location update possible

Use hot air blower to remove defective component. Avoid excessive heat! Watch surrounding components! Resolder new component afterwards.

E-commerce order number: L36334-Z93-C297

Soldering temperature: 240 - 255°C

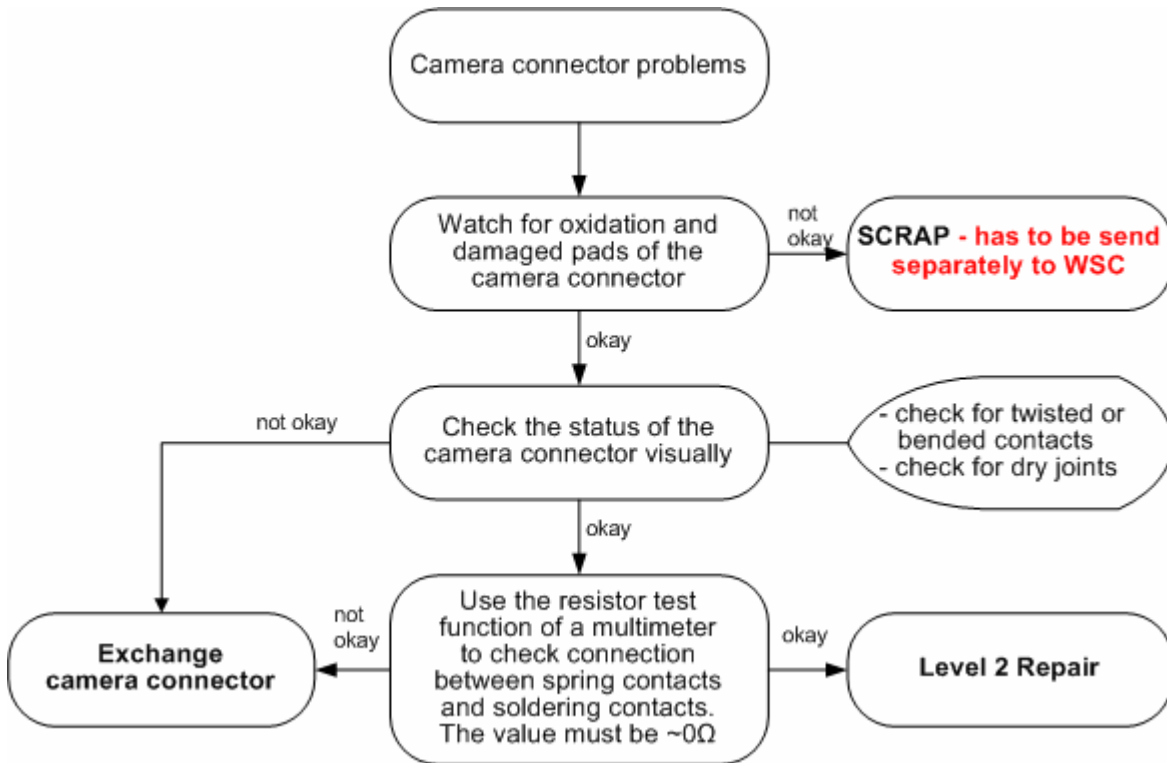
Connector CAMERA

Fault Symptoms	
Customer: Camera malfunction	GRT: Tbd.

Use hot air blower to remove defective component. Avoid excessive heat! Watch surrounding components! Resolder new component afterwards.

E-commerce order number: L36197-F5008-F341
 Soldering temperature: 240 - 255°C
 IRIS Diagnose Code: BA000 Accessories / Camera

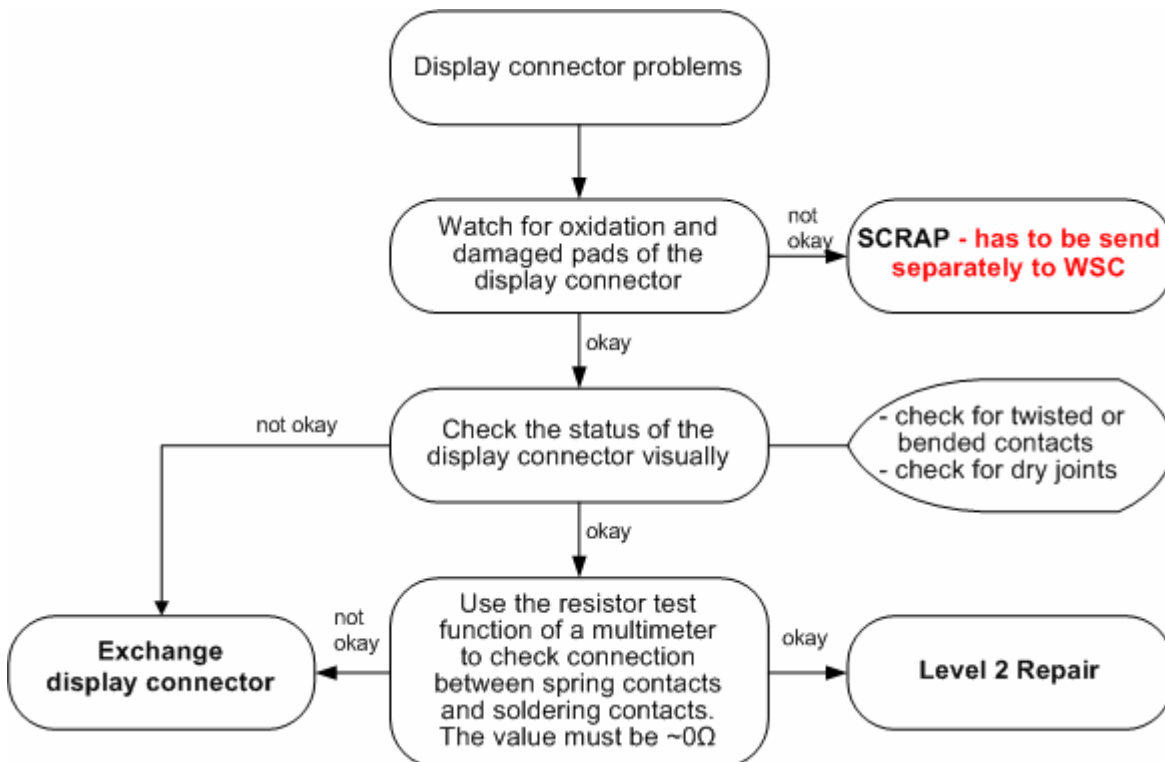
Connector DISPLAY

Fault Symptoms	
Customer: Display problems, like missing lines or columns on the LCD or display contrast problems or illumination problems	GRT: Display problems

Use hot air blower to remove defective component. Avoid excessive heat! Watch surrounding components! Resolder new component afterwards.

E-commerce order number: L36334-Z97-C205
Soldering temperature: 240 - 255°C
IRIS Diagnose Code: 21000 Display / Performance
22000 Display / Background Illumination

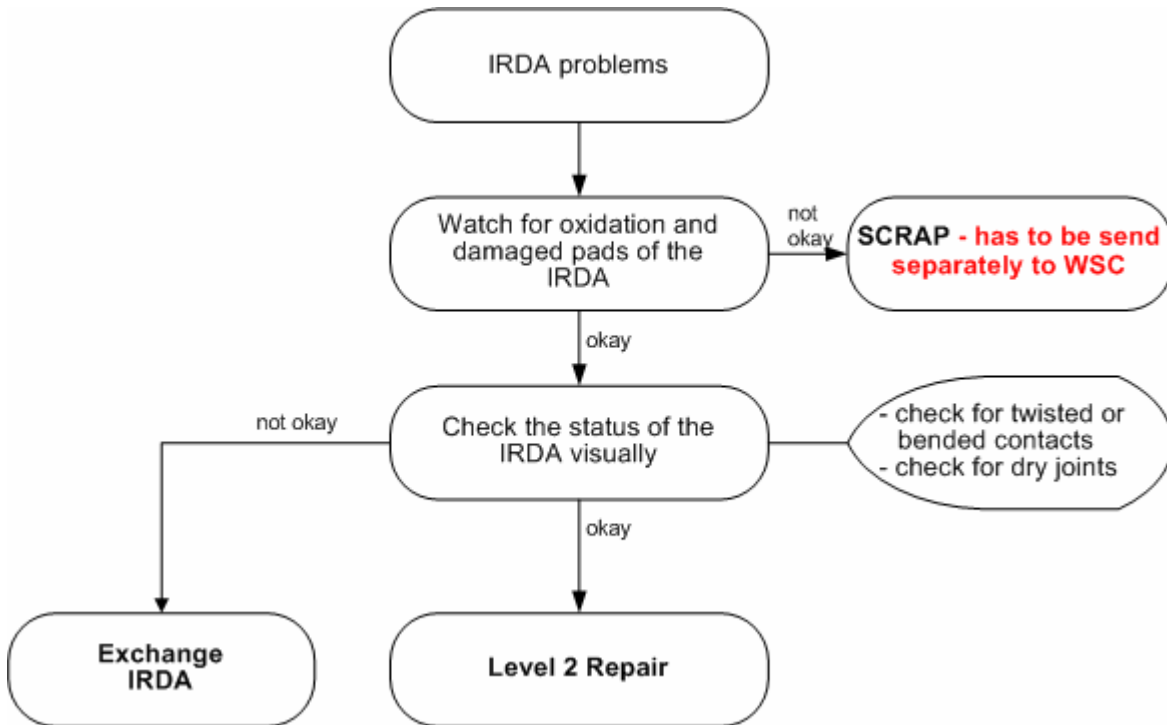
Fault Symptoms	
Customer: No infrared connection possible	GRT: Tbd.

Use hot air blower to remove defective component. Avoid excessive heat! Watch surrounding components! Resolder new component afterwards.

E-commerce order number: S65: L36810-U6130-D670
SP65: L36197-F5008-F492
Soldering temperature: 240 - 255°C
IRIS Diagnose Code: 41100 Interfaces / IRDA / No Function
41300 Interfaces / IRDA / Mechanical Damage

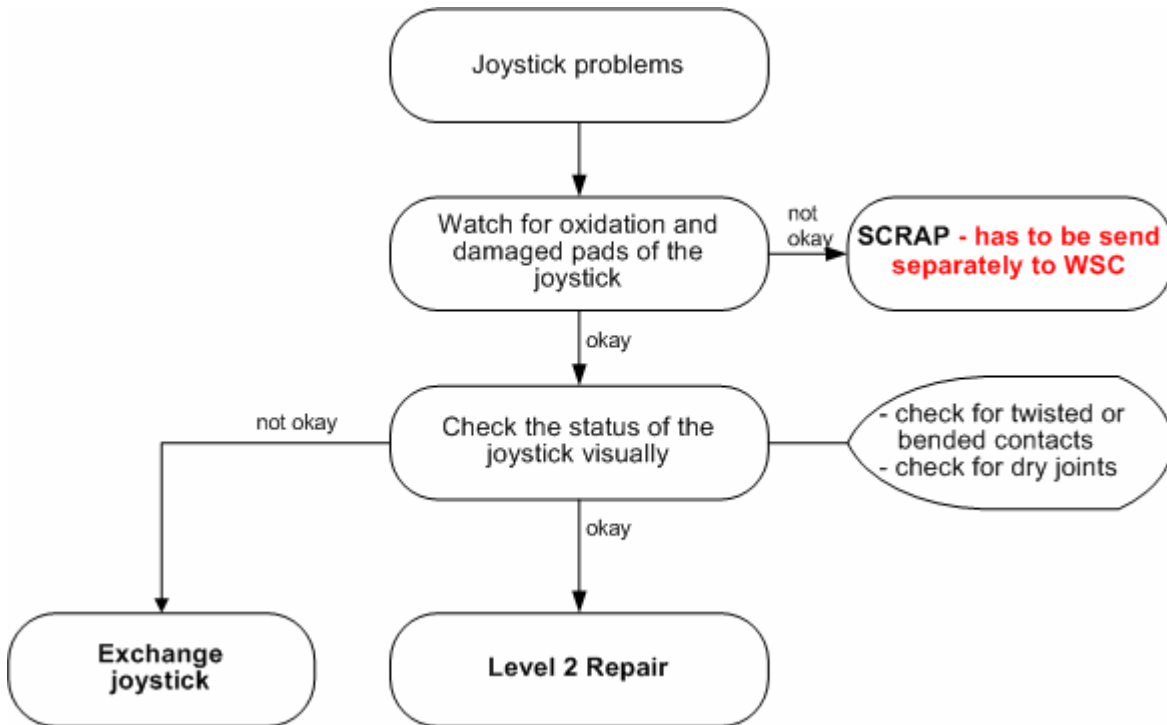
Fault Symptoms	
Customer: Joystick malfunction	GRT: Tbd.

Use hot air blower to remove defective component. Avoid excessive heat! Watch surrounding components! Resolder new component afterwards.

E-commerce order number: L36315-Z77-C218
 Soldering temperature: 240 - 255°C
 IRIS Diagnose Code: 32100 Keys / Main / No Function
 32200 Keys / Main / Reduced Functionality
