Service Repair Documentation

Level 2.5 light - S65, SP65

1 S65, SP65 board layout

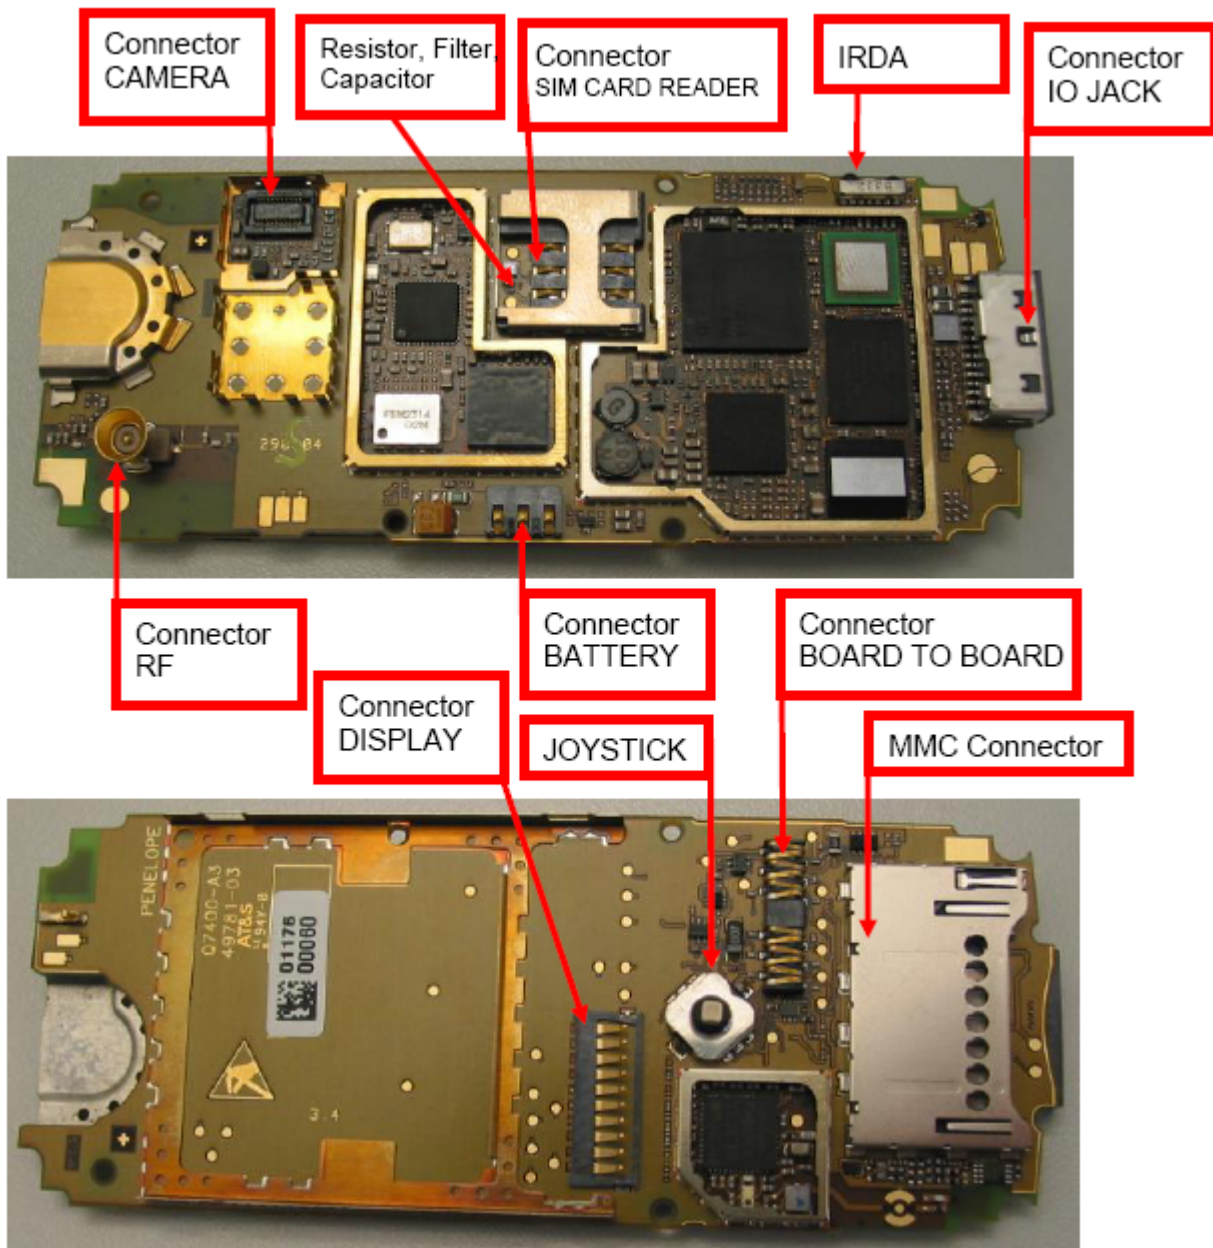
2 Connector SIM Card Reader

Fault Symptoms	
Customer: Handset does not accept SIM card	GRT: SIM Card Problems

Use soldering iron to remove defective component. Avoid excessive heat! Watch surrounding components! Resolder new component afterwards.

E-commerce order number: L36334-Z97-C337
Soldering temperature: 240 - 255°C
IRIS Diagnose Code: 43300 Interface/SIM Cardreader/Mechanical Damage
